**HYDROFLUIDIC STABILITY AUGMENTATION SYSTEM (HYSAS)
OPERATIONAL SUITABILITY DEMONSTRATION**

Honeywell Inc.
1625 Zarthan Avenue
St. Louis Park, Minnesota 55416

October 1977

Final Report for Period March 1973 - March 1977

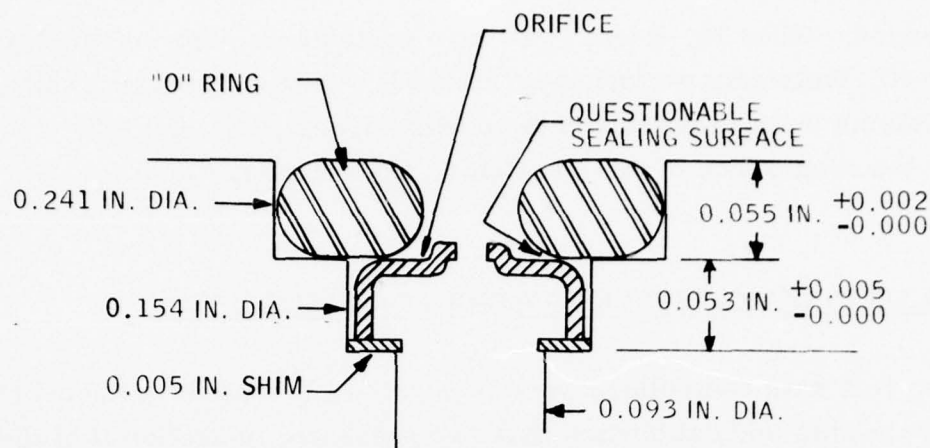
Figure 11. Sealing of Orifice Cup - Operational Suitability Design.

Under some conditions internal leakage occurred around the orifice restrictors, resulting in inconsistent calibration data. The configuration of the orifice installation is shown in Figure 11. The 0.005-inch-thick shim was added to maintain tighter contact between the "O" ring and the orifice cap. This general configuration is not recommended for future designs.

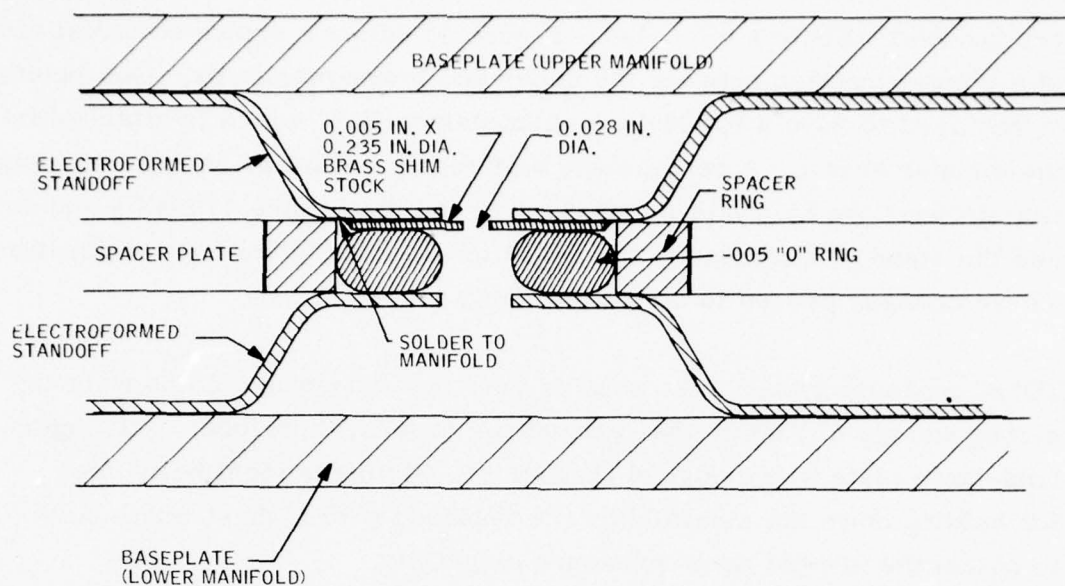
Figure 12. Cross Section of a Typical Junction Between Upper and Lower Manifolds.

reduce their effective diameter. Figure 12 shows a cross-sectional view of a typical junction between the upper and lower manifolds. One junction is required to have a 0.028-inch-diameter orifice, which is attached in the manner shown. A replaceable orifice cup cannot be used in this location because the height is insufficient to use the Figure 11 configuration and the standoff diameter is too small to use the Figure 13 configuration. These changes proved to be satisfactory.

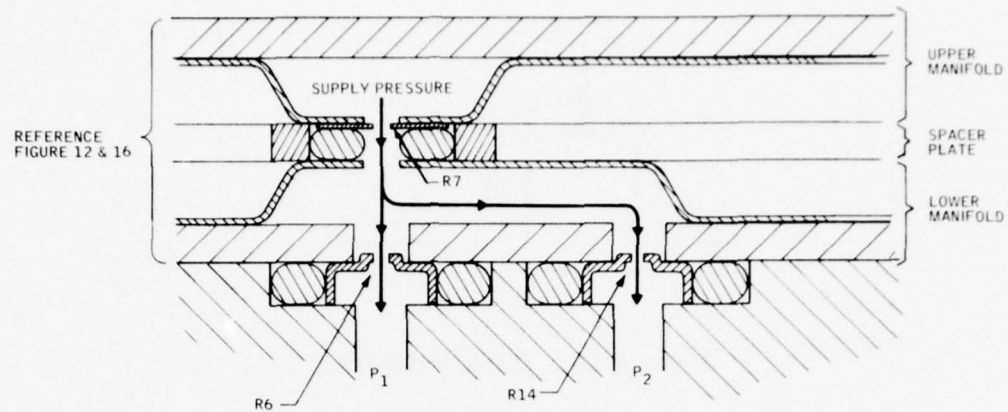
Figure 14. Original Bias Resistor Configuration.

The cause of a large, unexplained offset at the output of the high pass was determined to be the physical orientation of the bias resistors as shown in Figure 14. Because the flow through R7 impinged directly on R6, the recovered pressure at P1 is greater than at P2 even though R6 and R14 are equal. Figure 6 shows the location of these resistors in the circuit. This problem was solved by pressing a diverter plug into the lower manifold baseplate as shown in Figure 15 to prevent impingement of the stream from resistor R7 onto resistor R6.

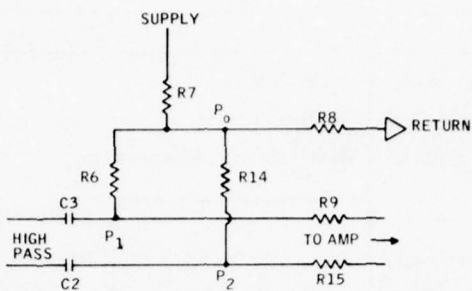
Figure 16. Bias Network.

Another bias circuit problem was uncovered while testing the system over a wide fluid temperature range. In the circuit shown in Figure 16, pressure P_1 usually equals P_2 and is lower than P_o . Under some temperature conditions, the pressure levels at P_1 and P_2 would increase such that they would become as large as P_o . In this case the pressure drop across R6 and R14 would be zero, and the resistance of R6 and R14 would be nearly zero. This would result in a short across the high

pass and very low system gain. The problem was solved by blocking resistor R8 and eliminating resistor R7, thereby ensuring a positive flow through bias resistors R6 and R14 at all times.

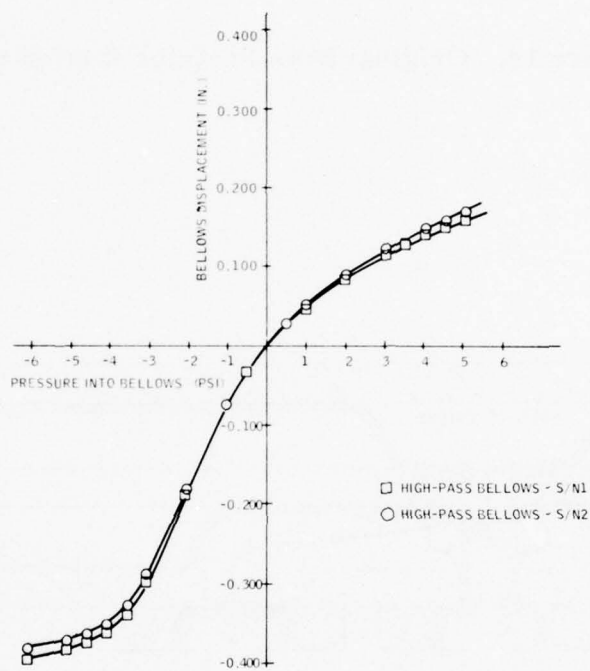
Figure 17. Nonlinear Bellows.

A nonlinear lag bellows that could change the lag time constant by a factor of three depending upon the amount of offset in the preamplifier presented another problem. This same bellows was tested on another program and was found to have the characteristic shown in Figure 17. Spring rate at 2 psid in compression was less than 10 psid per inch of deflection. This increases to 30 psid per inch at a pressure of 2 psid in extension. Nominal operating point for a lag is 0 psid (neither compression or extension); however, for a high pass the operating point can be biased to operate in the linear portion of the curve, which is about 2.5 psid in compression. A more expensive electroformed bellows with a linearity of about ± 5 percent was ordered for the lag circuit when the magnitude of the problem was realized.

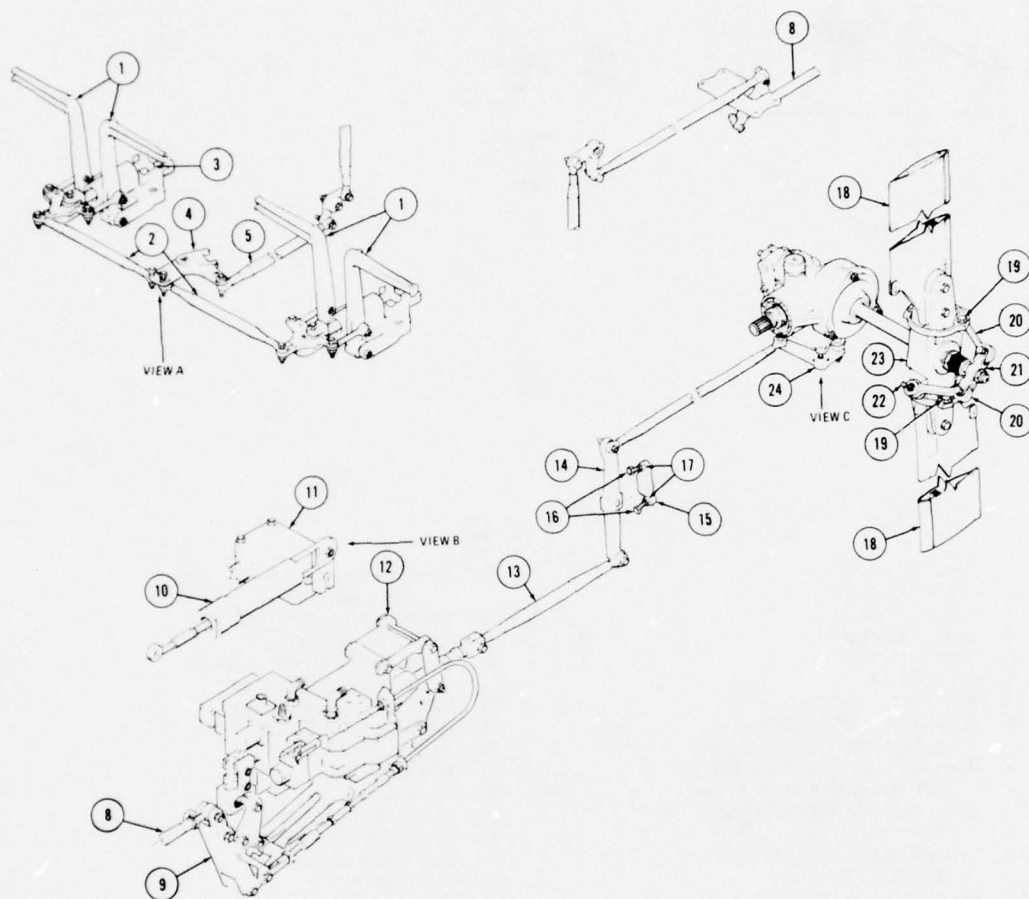
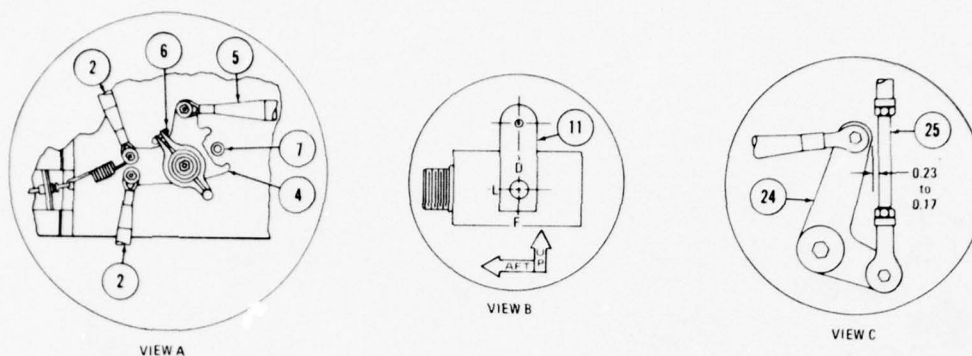
Figure 30. OH-58 Antitorque Control System.

During installation at Lowe Field in Fort Rucker, the problem of force feedback into the pedals occurred again and could not be corrected by shimming or adjustment (see HMR B02014). Yaw axis controller S/N 16 was removed from the aircraft and sent to Honeywell to determine if the problem could be duplicated in the laboratory.

The laboratory acceptance test fixture was modified to include the aircraft antitorque control lever (Item 9 in Figure 30) so that the magnitude of the effective pedal forces could be measured. Figure 31 is a photograph of the force-inducing summing linkage and Figure 32 is a detailed sketch. Tests demonstrated that excessive friction on the

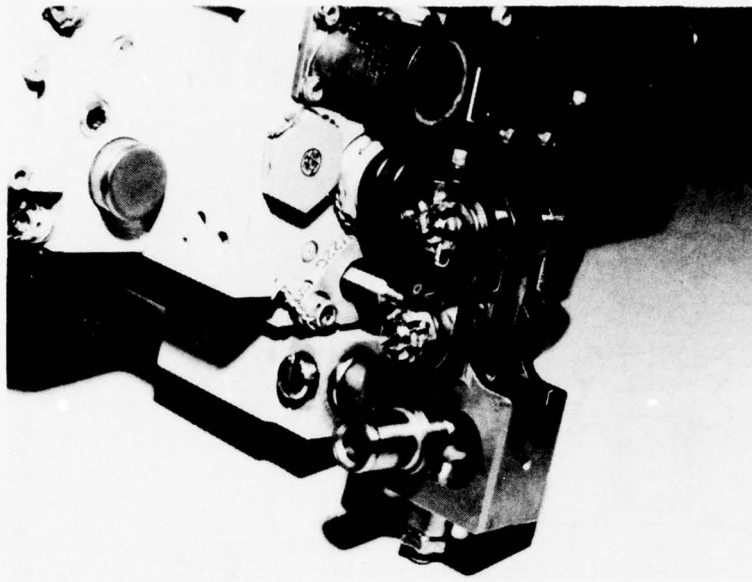
Figure 31. Servoactuator Summing Linkage - Photograph.

upper bolt caused the control servoactuator output to "kick" back into the pedals rather than move the servoactuator pilot valve. Experiments showed that proper shimming in the area of the upper bolt could prevent friction-producing misalignments. Inspection of the unit also showed that there was some wear between the lower spacer and its slot in the rod end assembly.

Review of the linkage design included a review of the results of the described tests, results of previous flight tests on a very similar design, and data on the original design. It was concluded that the force feedback problem could be eliminated by incorporating the changes outlined in Figure 33. The upper bolt was modified to accept an aluminum bronze bushing, thereby providing a good bearing surface for the center link. The 15-5PH sleeve was used to hold the bushing in place and to provide proper spacing for the upper bolt linkages. Shims were to be used to maintain proper alignment of the upper bolt linkage. The lower spacer was

replaced with a smaller diameter unit to prevent contact. It was anticipated that this retrofit would solve the binding problem; however, it was also recognized that this was an interim configuration and that a complete redesign would be required on future builds of similar hardware. A stress analysis on the revised design showed that the new bolt design was acceptable under all static, dynamic, and ultimate load conditions. All summing linkage in the field was modified to incorporate the described changes in August 1975.

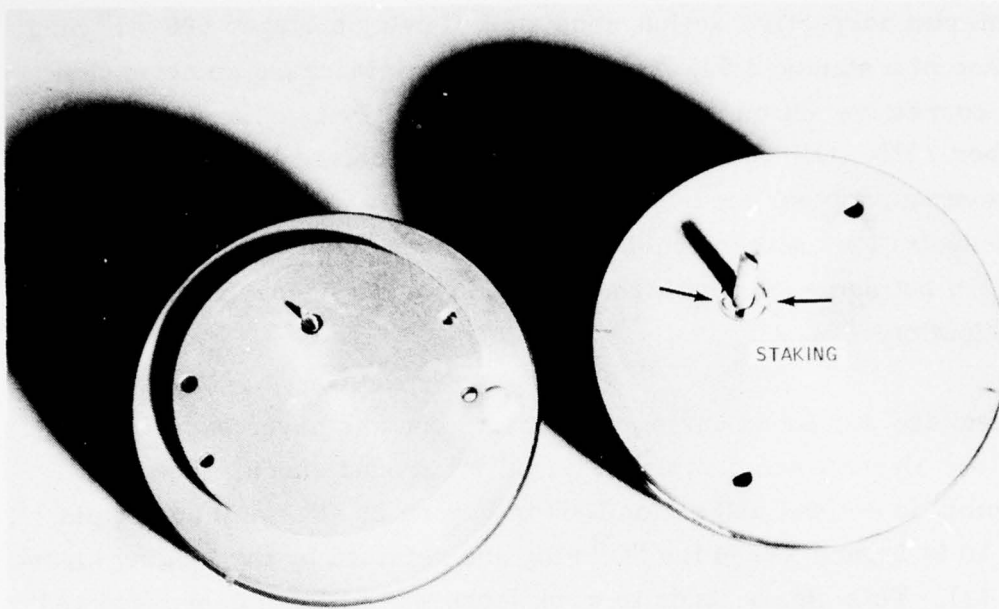
Figure 34. Staking of BIT Locking Sleeve.

BIT leakage was found during installation but was never experienced after the aircraft had completed its initial ground check. The BIT assembly is defined as Section D-D in Figure 2. The null adjust pin (No. 10 in Figure 2) and the "O" ring are retained by the locking sleeve (No. 11). This sleeve tends to work loose when BIT is depressed and released repeatedly (i. e., when the null adjust pin is rotated repeatedly). To correct the problem, this sleeve was permanently "staked" using a center punch on all units. This "staking" can be seen in Figure 34. All of the OH-58 units and some of the TH-57 units received this modification before they were shipped. The remaining TH-57 units were modified on site in Pensacola.

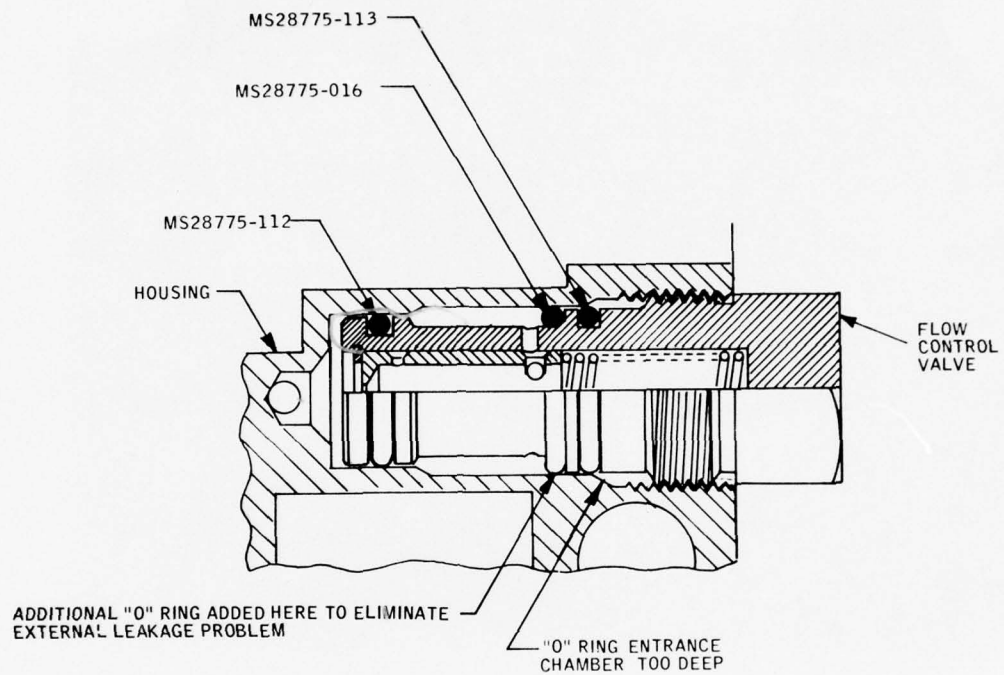
Figure 35. Flow Control Valve Installation.

Flow control valve leakage resulted because the "O" ring entrance chamfer was machined too deep in the controller housing. "O" ring compression was sufficient on most units, preventing any leakage; however, some slight leakage was experienced on a number of other units. Figure 35 is a sketch of the flow control valve installation. An additional "O" ring was incorporated in the location shown in Figure 35 on Pensacola controllers during October of 1975. OH-58 units received this corrective action only when they were returned to Minneapolis or when they showed signs of leakage. Flow control valve leakage was the subject of HMRS B02009 and B02028.

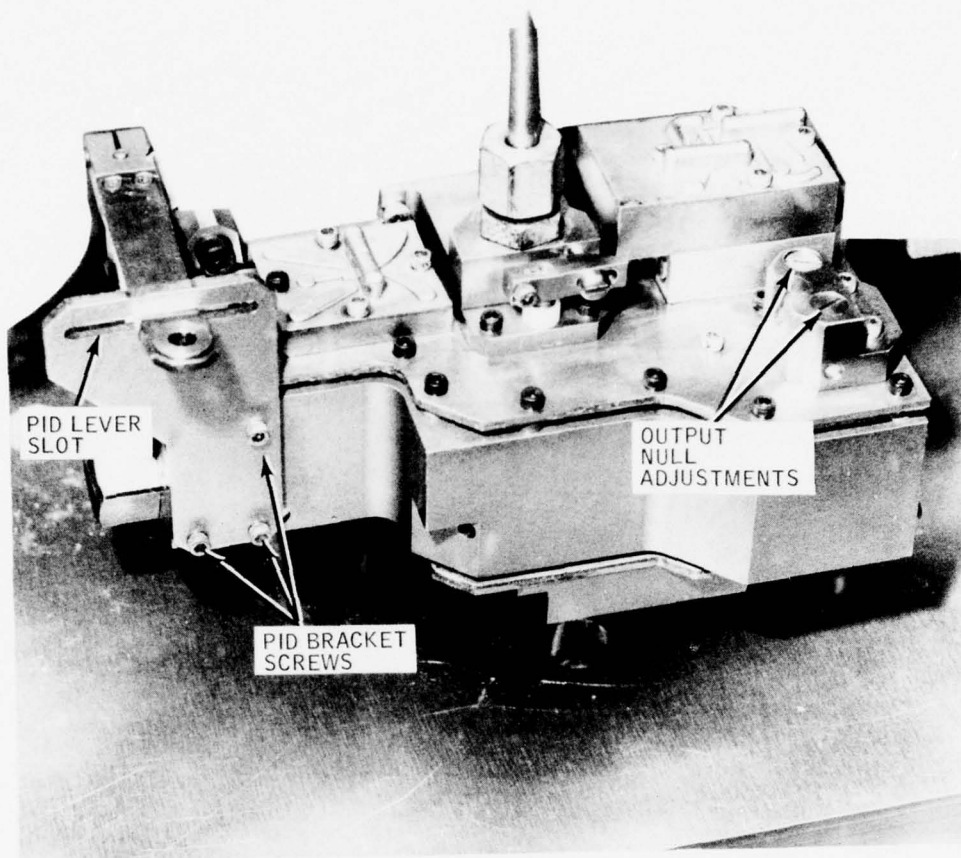
Figure 36. Yaw Axis Controller.

Most of the mishandling problems occurred during the shipment of yaw axis controllers mounted on their servoactuators. Shearing off of the PID bracket screws, Figure 36, was the most common occurrence and is reported in HMRs B02003, B02006 and B02013. This servoactuator assembly is relatively heavy and subject to damage during packing, shipment, and unpacking. The exact point where and how the malfunction occurred has not been determined. Improved packaging greatly reduced the mechanical damage experienced during shipment; however, some servoactuator assemblies are still damaged when they are returned from the field.

Slippage of an output null adjustment (Figure 36) is the suspected cause of malfunction B02053. This adjustment is secured by friction, and a rubber base adhesive is applied after controller calibration is completed. Positive locking means will be used in future applications.

sometimes manipulated quite forcefully to obtain required alignment during installation. Both the PID bracket and the servovalve can be easily redesigned to be more tolerant of abuse. In production, the packaging would also be redesigned to prevent shipping damage.
